TXT 4.0 Controller Troubleshooting - no connection with ROBO Pro Coding possible, and “txtapi” is displayed

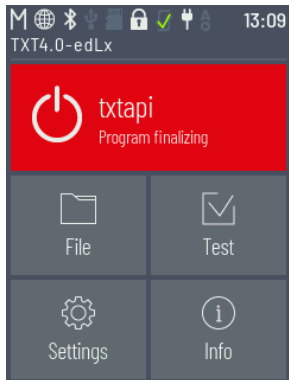
If the TXT 4.0 Controller displays the red button labeled “txtapi” approx one minute after it is switched on for the first time, then a connection cannot be formed with ROBO Pro Coding.

This error can be corrected as described in this document. The software on the TXT 4.0 Controller will be replaced.

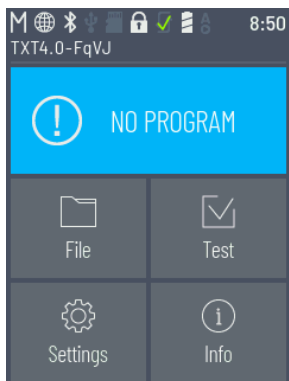
If “NO PROGRAM is displayed after this process is complete, then the error was successfully corrected, and the Controller can be connected to ROBO Pro Coding once again.
