TXT 4.0 Controller Troubleshooting - no connection with ROBO Pro Coding possible, and “txtapi” is displayed

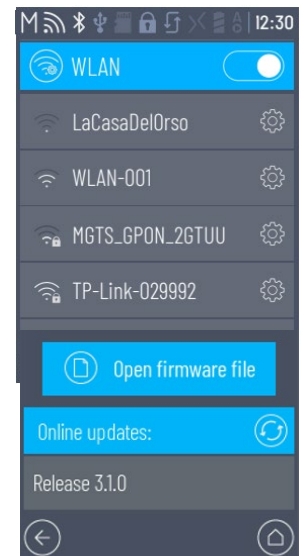
If the TXT 4.0 Controller displays the red button labeled “txtapi” approx one minute after it is switched on for the first time, then a connection cannot be formed with ROBO Pro Coding.

1. To complete an update, the TXT 4.0 Controller must be connected to the internet via Wi-Fi. To do so, select an internet router for the appropriate SSID / Wi-Fi network in Settings / Network / Wi-Fi.

2. Select the latest version in Setting / Updates/ Online Updates / Online Updates: and Release 3.1.0, then press “Installation.” The installation will be completed. This process will take several minutes.
3. Afterward, the Controller must be switched off and back on again manually. Please ensure that the Controller boots up and remains switched on for approx. one minute.
